Solmetric Module Lift Electroluminescence (EL) Testing

6/29/2022

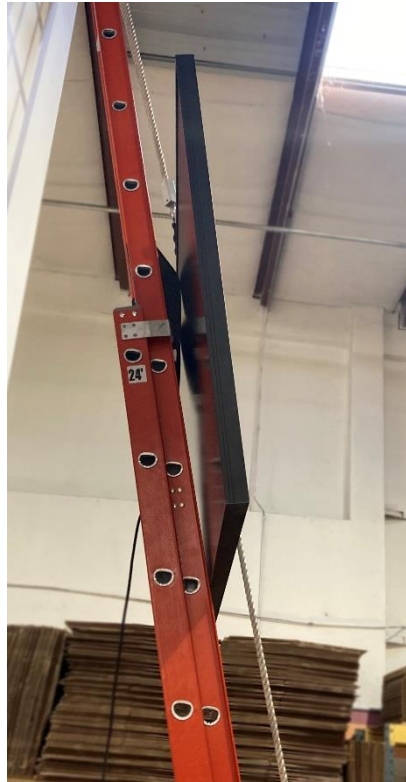
The Solmetric Module Lift was tested to assess whether its use causes micro-cracking of module cells. The module slides up the outer rails of the ladder and over plastic “ramps” that guide the module over steps between ladders sections and ladder brackets. Modules are raised up the ladder with the glass facing the ladder. Tests were performed with a two section fiberglass ladder extended 19 feet and leaned at an angle of approximately 75° relative to the ground. The ladder had two ramps that the module would pass over on the way up the ladder and again on the way down the ladder. Electroluminescence (EL) images were captured of module before being used with the Module Lift and again after multiple passes up and down the ladder.

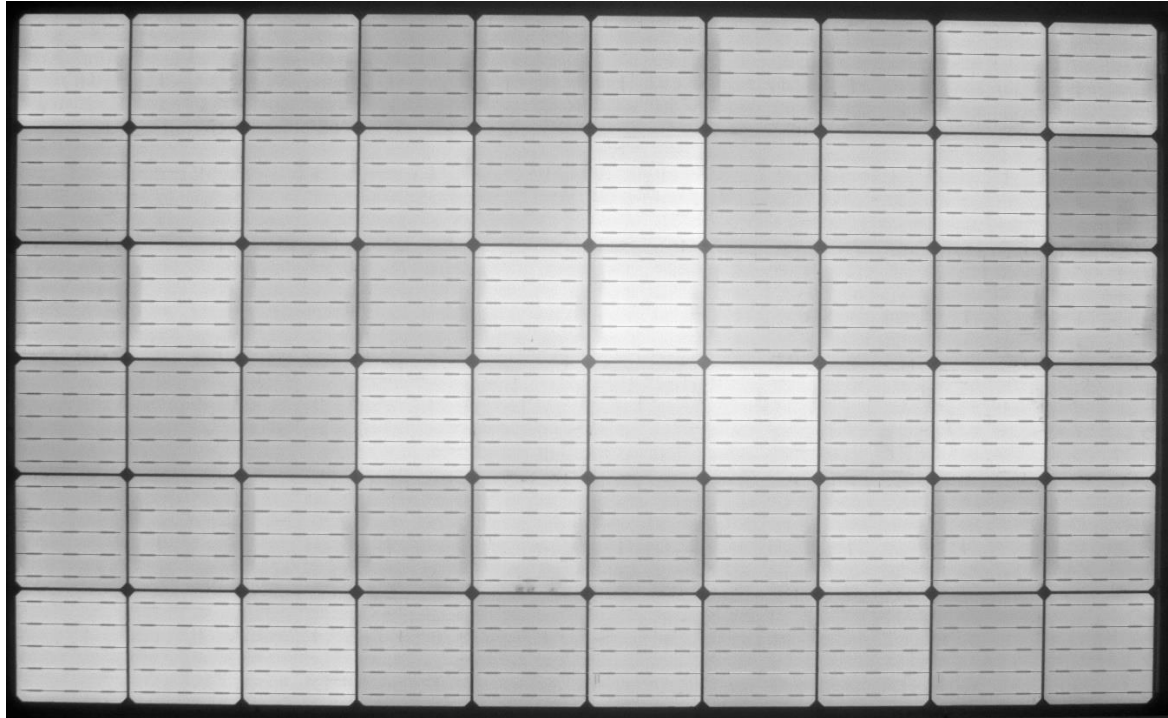
Test 1 -- New Jinko JKM290M-60B module

The top image below was taken before any uses with the Module Lift. This is a new module. It shows a few small pre-existing micro-cracks. The bottom image was taken after 10 passes up and down the ladder (40 ramp passes). No new micro-cracks were detected. No existing micro-cracks deteriorated.

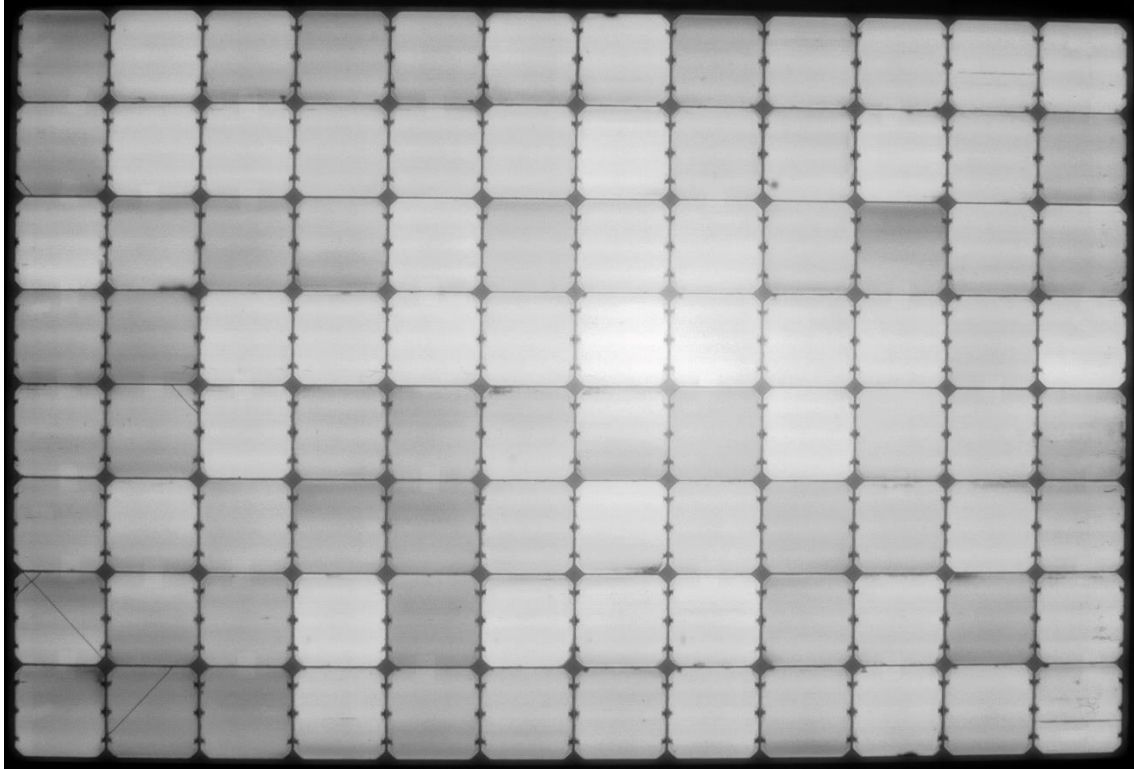
Test 2 – Used Sunpower SPR-X22-360-COM module

The top image below was taken before any uses with the Module Lift. This module is used and was taken of a pole array. It shows multiple large pre-existing micro-cracks. The bottom image was taken after 5 passes up and down the ladder (20 ramp passes). No new micro-cracks were detected. No existing micro-cracks deteriorated.
